# NEWMAR CORPORATION WARRANTY DEPARTMENT

## TECHNICAL SERVICE BULLETIN

| DATE ISSUED | MODEL YEAR(S) AFFECTED | TSB # |
|---|---|---|
| 8/18/2016 | 2017 | 462 |

## How to Secure Fascia at Rear of HWH Flat Floor Slideout

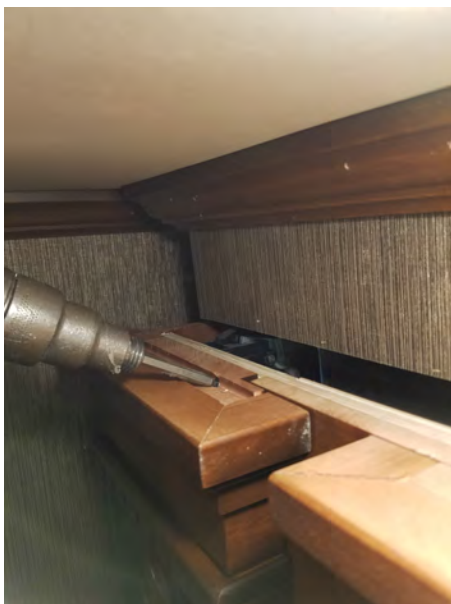
Dutch Star - Rear Fascia - Top

Verify there is a screw in the top block. If not, install one.

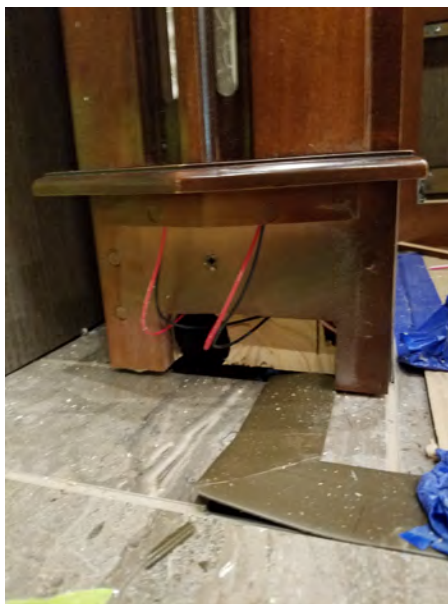
Dutch Star - Rear Fascia - Bottom

Pull the lower block off the fascia leg. Verify whether there is a screw into the structural fascia. If not, install one.

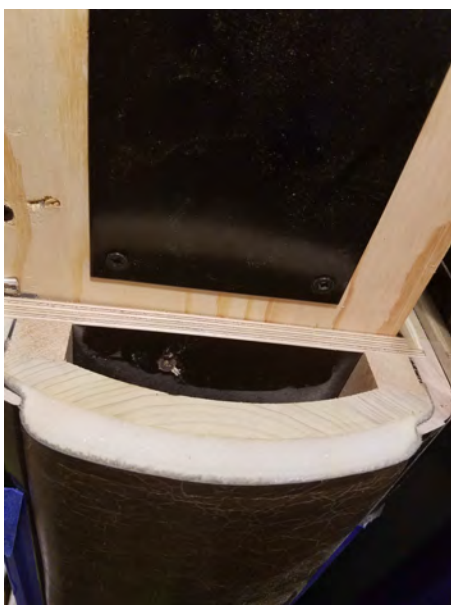
King Aire - Rear Fascia - Top

Remove top corner block, verify there is a screw at the top. If not, install one.

Reinstall the top block with the magnet. Be sure the magnet is attached tight against the metal plate.

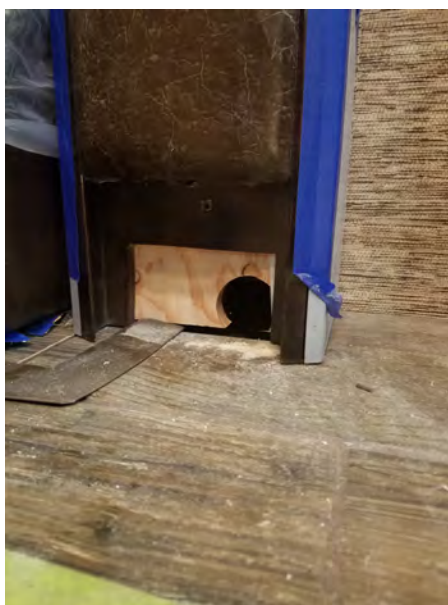
King Aire - Rear Fascia - Bottom

Pull or push up the vinyl insert a few inches exposing the inside of the fascia at bottom. Verify that there is a screw installed. If not, install one near the bottom.

Push or pull the insert back down into place.

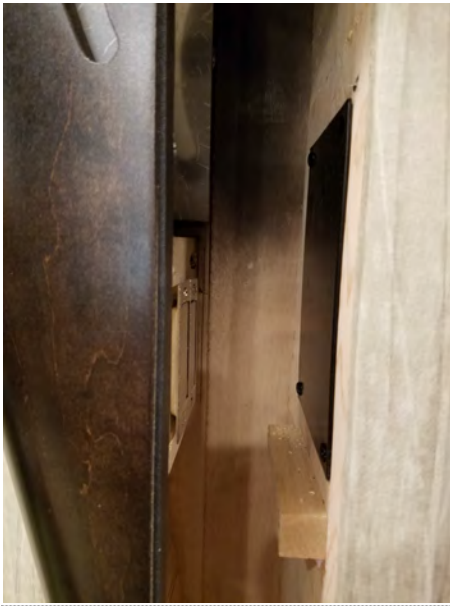
London Aire - Rear Fascia - Top

Pull the rear fascia wood out a few inches -- just enough to see the magnets and plates. Do not pull the bottom out too far because there are wires attached.

Mark backer's location so you will know where to install the screw.

Replace the rear fascia wood and install screws from the back side. Be careful to avoid the magnet and magnet plate, but still catch the wood backer.

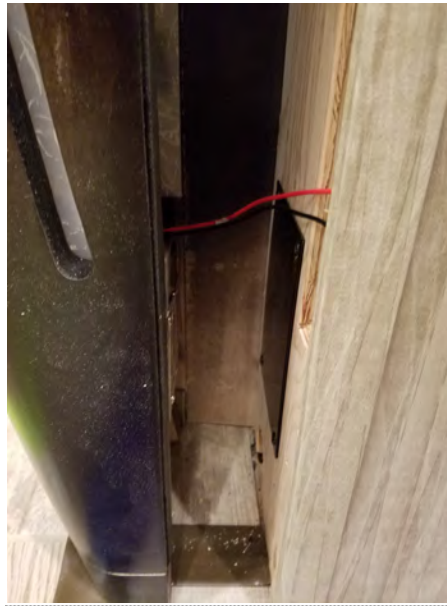
London Aire - Rear Fascia - Bottom

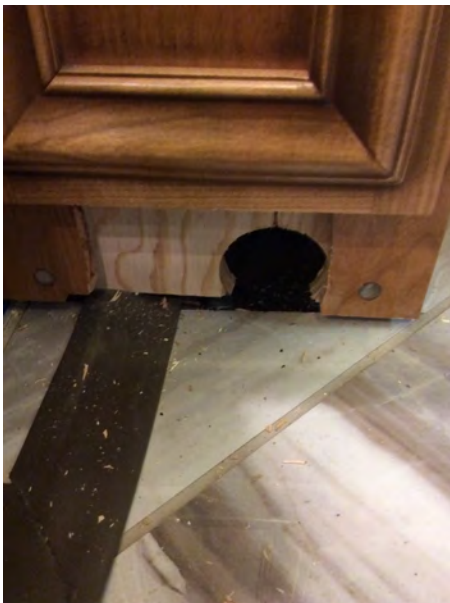
Mountain Aire - Rear Fascia - Bottom

Remove the lower block, which is attached with magnets. Verify there is a screw holding the rear fascia behind the block. If not, install a screw to the fascia.

Reinstall the lower block.

Verify top magnet is holding fascia secure. If not, install a screw from the back side of fascia.

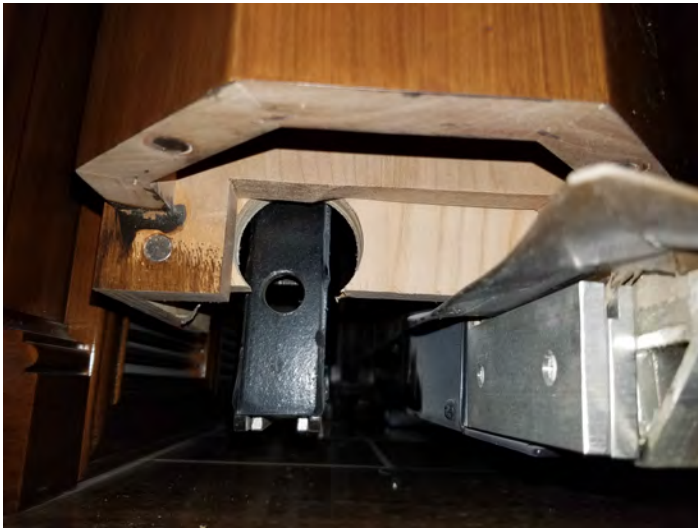
Essex - Rear Fascia - Bottom

Remove the lower block, which is attached with magnets. Verify there is a screw holding the rear fascia behind the block. If not, install a screw into the fascia.

Reinstall the lower block.

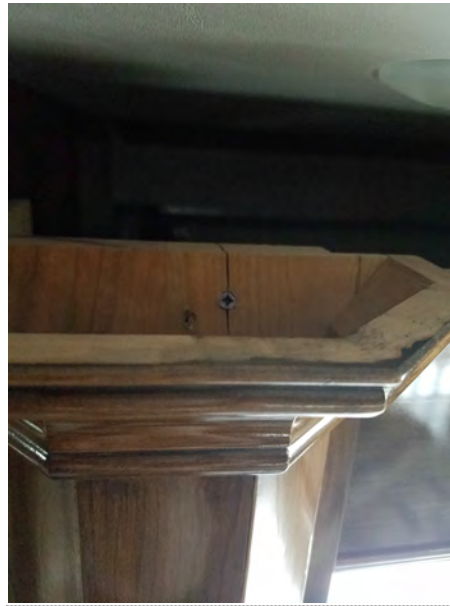
Essex - Rear Fascia - Top

Verify there is a screw in the top block. If not, install one.
