RECALL SERVICE BULLETIN

469

November 2016
FL723AB
NHTSA #16V-654

Subject: FCCC Motorhome Brake Lights and Towed Device Brakes (Straight Pedal)

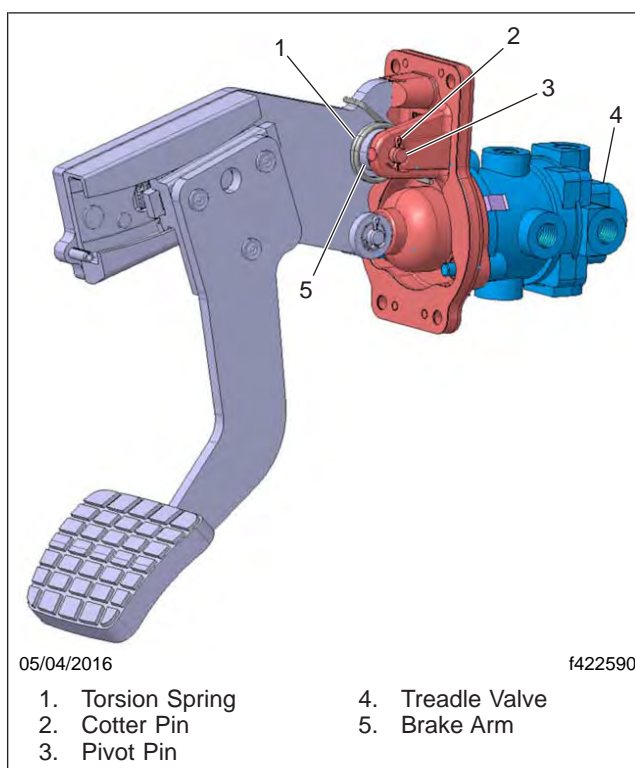
Fig. 1, Brake Pedal Assembly

1. Check the base label (Form WAR259) for a completion sticker for FL723 (Form WAR260), indicating this work has been done. The base label is usually located on the front wall under the dash. If a sticker is present, no work is needed. If there is no sticker, proceed with the next step.
2. Park the vehicle on a level surface, shut down the engine, and set the parking brake. Chock the tires.
3. Inspect the brake pedal assembly for a torsion spring. See [Fig. 1](#), item 1.

4. Remove the accelerator assembly.
5. Remove and discard the cotter pin. See [Fig. 1](#), item 2.

To remedy the issue, a new torsion spring will be added to the pedal assembly to improve the pedal return.

6. Using a blunt tool, push the pivot pin out.
7. Install the new torsion spring on the service brake pedal. See [Fig. 1](#), item 1.
8. Install the pivot pin removed earlier.
9. Install the new cotter pin, bending the ends of the pin over to secure it in place.
10. Install the accelerator assembly.
11. Start the vehicle. When the air tanks have reached approximately 65 to 76 psi (448 to 524 kPa), depress and release the brake pedal several times. Exit the vehicle and verify that the brake lights are not activated.
12. Clean a spot on the base label (Form WAR259). Write the recall number, FL723, on a blank red completion sticker (Form WAR260), and attach it to the base label to indicate this campaign has been completed.
