# TECHNICAL SERVICE BULLETIN

490

Newmar has decided to install an override switch for the HWH step to provide a way to operate the step from inside the coach in the event of a sensor or door switch failure.

# How to Install an HWH Step Override Switch

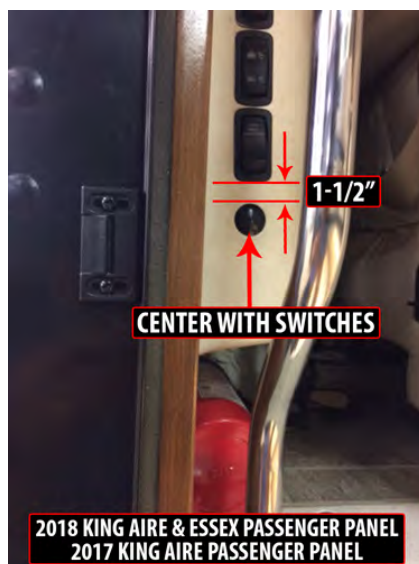
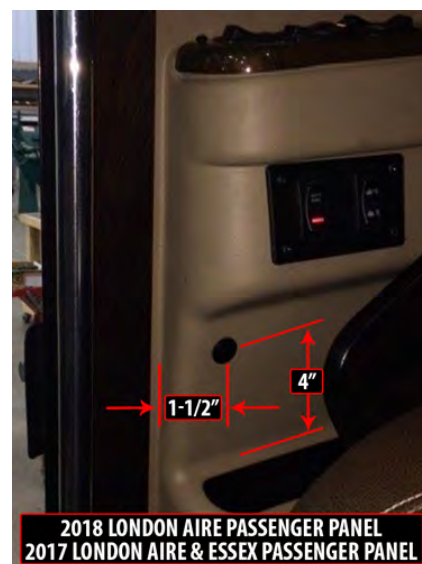
1. Mark the switch location.

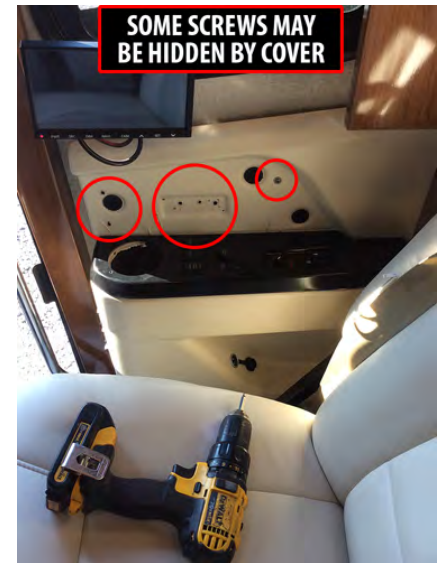
2. Remove the passenger side console panel from the wall. Some screws may be hidden by covers held on by Velcro.
3. Pull out enough of the panel to access the wires.
4. Using the drill and step bit, drill a 3/4" hole for switch. Make sure the wiring is out of the way of the drill bit.
5. Check the switch fit often to make sure the hole is not too large.
6. Install the switch, and tighten it in place.

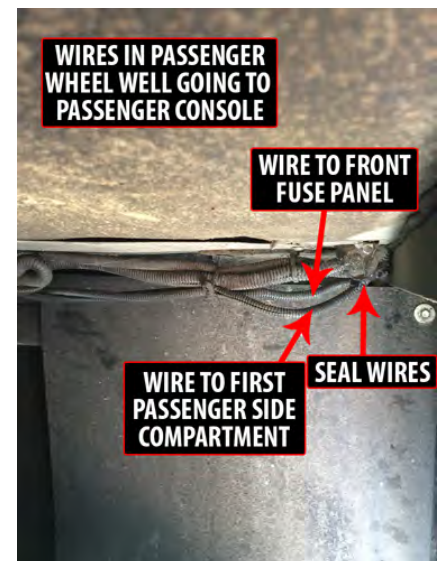
8. Run the wire and strap it along the following path:
  - From the driver's front fuse panel
  - Out the back around the frame rail to the front
  - Across the firewall
  - Down the passenger frame rail
  - To the passenger side wheel well
  - Up in the front corner of the wheel
  - Into the passenger side console.

9. Make a loop of wire in the passenger side console (enough to get to the switch).
10. Run the wire around the wheel well and down the frame rail to the first compartment just above the Miom.
11. Strap the wire up with cable ties as needed.

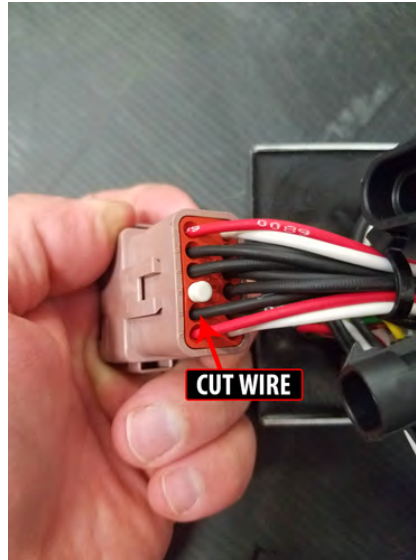
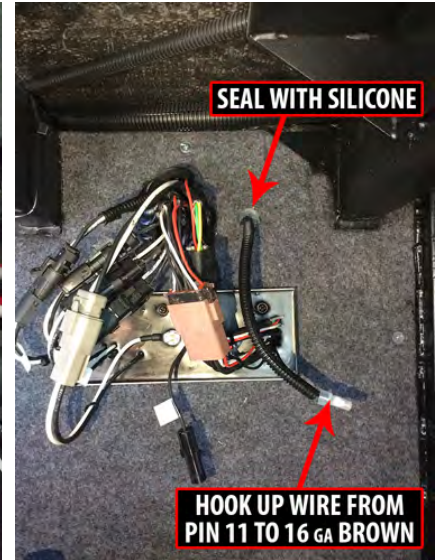
12. Drill a hole for the wire and loom.
13. Pull the wire through the hole using fish tape (if needed).
14. Remove the current Miom, and install a new Miom, which has a wire in the brown connector to pin 11.

15. Cut the wire at pin 11 on the plug, and then hook up to the 16 gauge brown wire ran from the passenger side console.

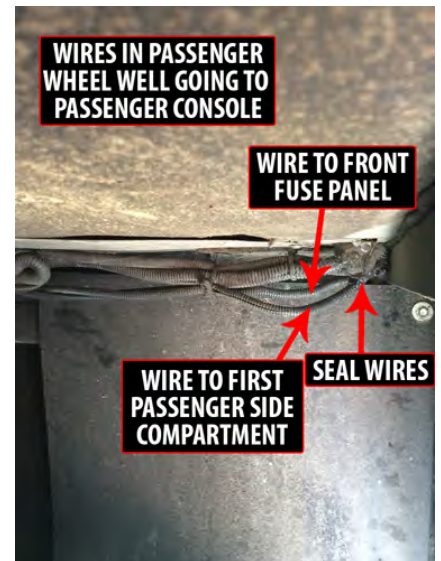
16. Seal the hole, loom, inside of the loom, inside of the compartment, and the outside of the compartment.
17. Seal the wire leading up to the passenger console in the wheel well area.
18. Seal the wire leading through the front driver side electrical compartment.
19. Mark (label) the wire at each end.

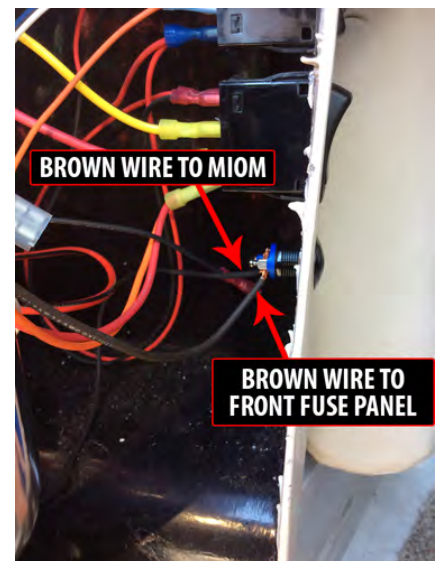
20. Cut the wire loop at the console in half.
21. Strip each wire end back, and hook up one 16 gauge brown wire to each terminal on the switch previously installed in the console.
22. Secure the console to the wall.
23. Reinstall any covers that were previously removed.

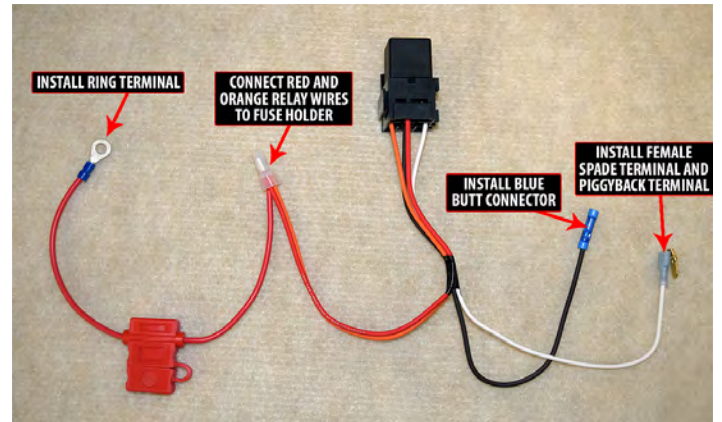
1. Cut the fuse holder wire in half, and strip the wire ends.
2. Hook the red and orange relay wire together, and connect them to one side of the fuse holder.
3. Install a ring terminal on the other side of the fuse holder.
4. Install a female spade terminal on the white wire.
5. Install the piggyback terminal on the white wire.
6. Crimp a blue butt connector onto the brown relay wire.
7. Label the fuse holder "Step Override."

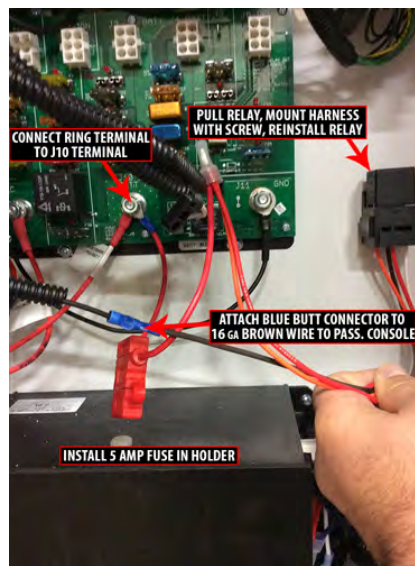
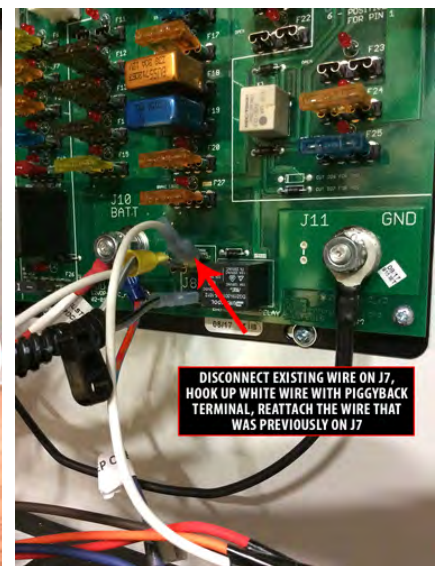
1. Pull the relay out of the harness, and fasten the harness with a screw.
2. Insert the relay back into the harness.
3. Hook up the brown relay wire to the 16 gauge brown wire leading to the passenger console with a blue butt connector.
4. Remove the wire from terminal J7 on the fuse panel.
5. Slide the piggyback terminal on J7, and attach the wire onto the piggyback terminal on J7.
6. Hook up the ring terminal attached to the fuse holder to the J10 battery terminal on the fuse panel.
7. Install the five amp fuse in the fuse holder.
