# NEWMAR CORPORATION

## RECALL SERVICE BULLETIN

505

# MARKER LIGHT AND HEADLIGHT WORK INSTRUCTIONS FOR RECALL 17V 797

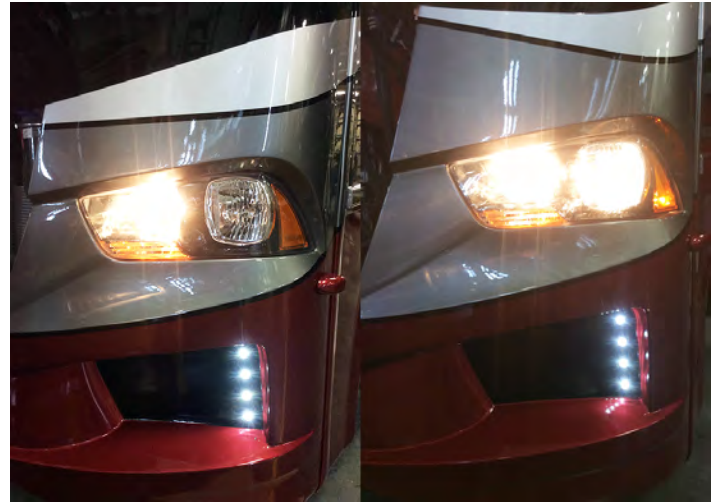
Recall 17V 797: The front side marker lights are not connected into the wiring harness. When the headlight high beams are activated, only the high beam bulbs illuminate. The intention of the high beam function on the affected coaches is to have both the high beam and low beam bulbs illuminate together.

*Marker Lights and Headlights on high beam before the harnesses are installed (left) and after the harnesses are installed (right).*

Follow the service procedure below to correct the condition.

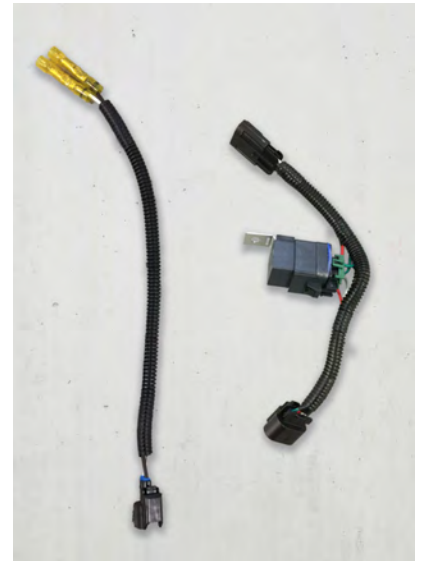
*New Marker Light Harness (Left) and Headlight Harness with Relay (Right)*

1. Inspect the coach to ensure the update is necessary by activating the headlights on the high beam setting while inspecting the headlamps and marker lights.
2. If the update is necessary, begin the correction process with the headlights and the marker lights turned off.
3. Crawl under the front cap at the headlight area.
4. Find the existing headlight and marker light harnesses.
5. If necessary, cut the cable tie to separate the wire harnesses.

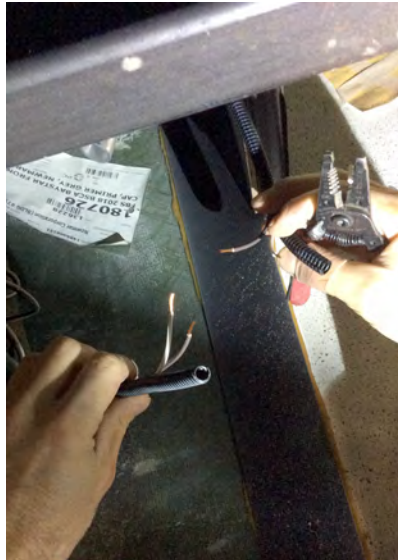
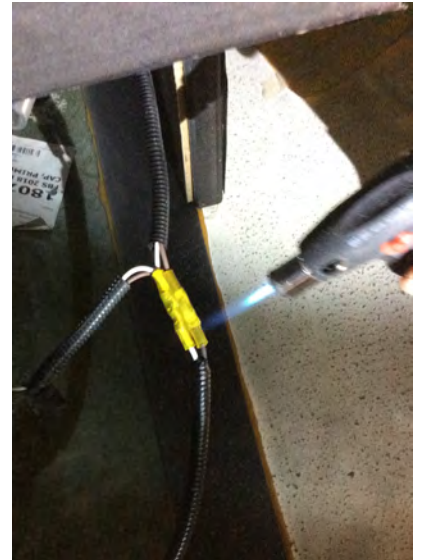
6. Cut the wire feeding into the four lower marker lights.
7. Pull the wire ends out of the loom, and strip the end of each wire.
8. Twist the white wires together, and crimp the yellow connector from the new marker light harness to the white wire.
9. Twist the brown wires together, and crimp the yellow connector from the new marker light harness to the brown wire.
10. Cut off the excess flexible conduit.
11. Heat the butt connectors with a small torch or lighter to create a water tight seal.

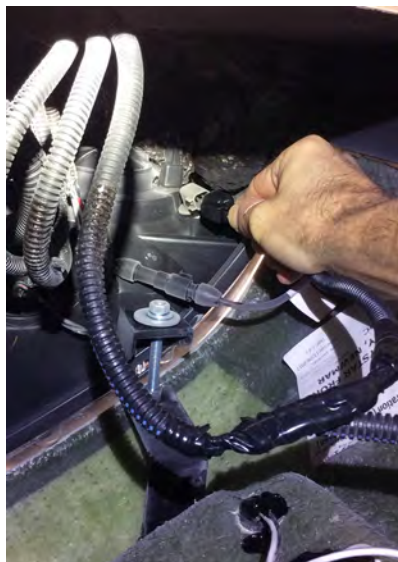
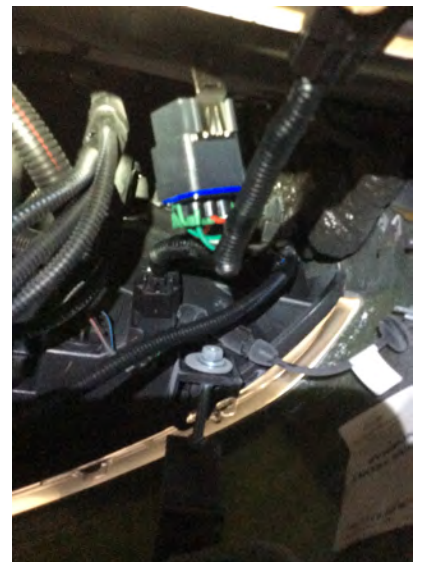
10. Tape the harness (using black tape), and plug the harness into the marker light location.
11. Locate and remove the existing headlight harness from the headlight.

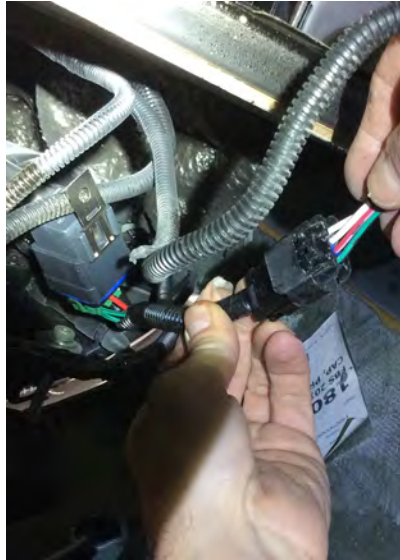
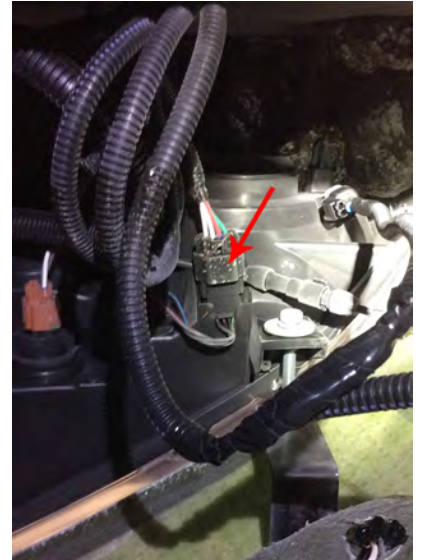
12. Plug the matching end from the new headlight harness into the headlight plug, and make sure it locks in place.
13. Plug the other end of the new headlight harness into the existing headlight harness, and make sure it locks together.

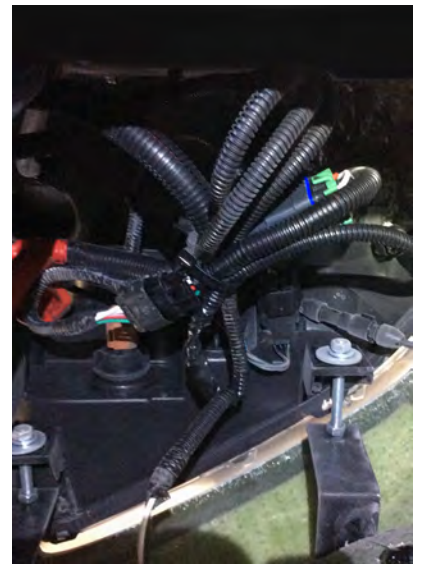
14. Strap harnesses together with a wire tie.
15. Repeat the process for the opposite headlight, as well as for the marker light.

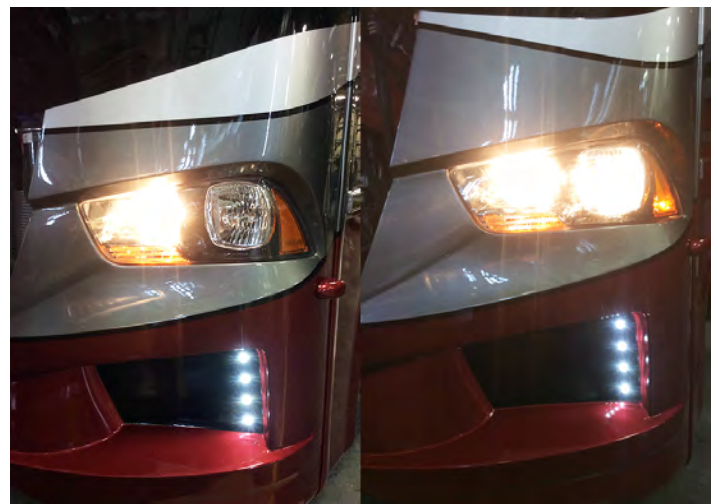
16. Test the headlights and marker lights after the harnesses are installed. If done correctly, both headlights, both marker lights, and the lower four LED lights should all be illuminated when the headlight high beam setting is activated.

*Marker Lights and Headlights on high beam before the harnesses are installed (left) and after the harnesses are installed (right).*
