## RECALL SERVICE BULLETIN

Spartan Motors has decided that a defect relating to motor vehicle safety exists in specific motorhomes built on Spartan chassis. In response, Newmar Corporation is issuing recall NHTSA# 18V 307, TC# 2018-253.

## Recall Service Bulletin

**CONDITION:** Minimal clearance between the tag axle tire and diesel exhaust fluid (DEF) fill support bracket.

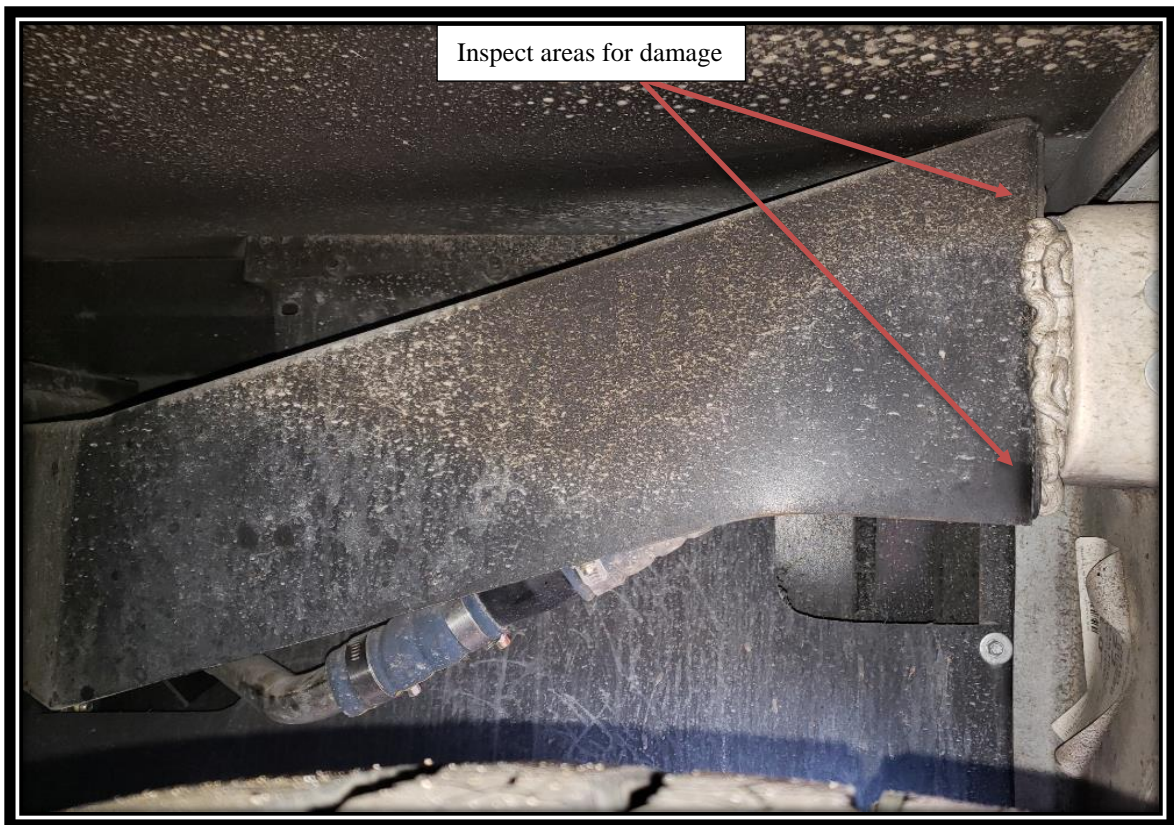
**FIG. 2-1**

- b. If tire damage is present, contact Spartan Customer Service (tire is not part of service kit)  
Tel: 855-589-9836
  5. Locate DEF fill support mounted in rear of tag axle wheel well and inspect for damage. Refer to FIG. 2-1.
    - a. Pay special attention to bracket and body interface at location of plastic DEF fill.
    - b. If damage has occurred to plastic DEF fill it should be replaced.
    - c. If DEF fill is damaged contact Customer Service (P/N 908-1272-01 {PIA in 2772-LL2-001} is not part of the service kit)

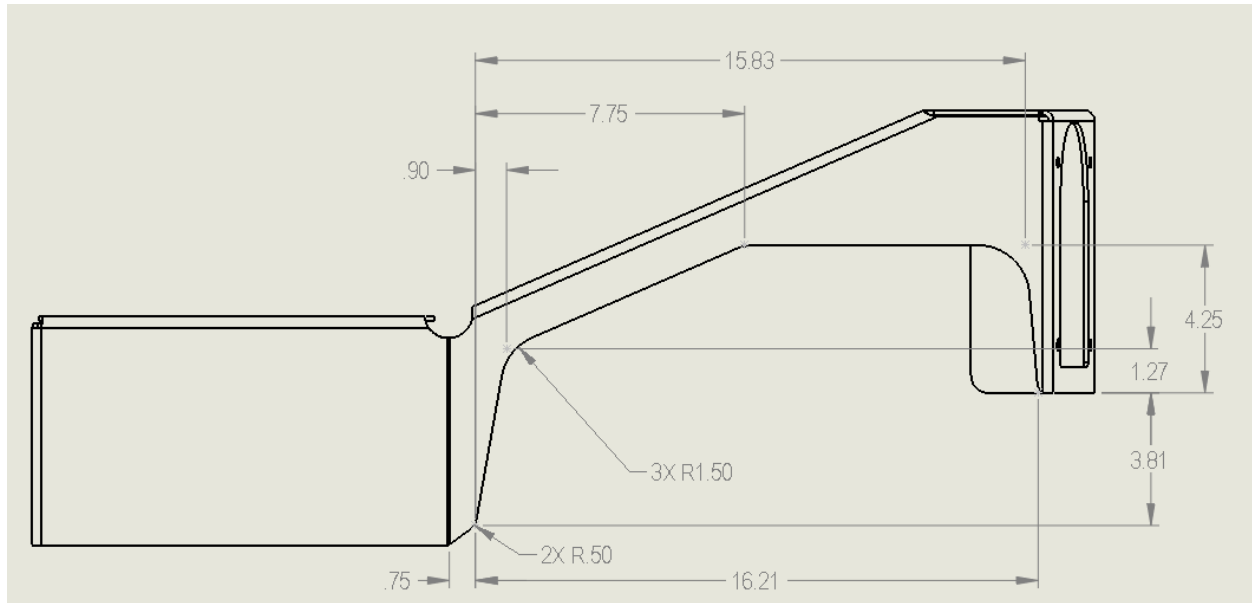
**FIG. 3-1**

6. Using dimensions provided, layout cut pattern. Refer to FIG 3-1.
7. Carefully cut bracket, cut-off wheel or Sawzall preferred. Remove and properly dispose of cutoff portion of bracket. **Use caution not to damage the DEF fill and hose.**

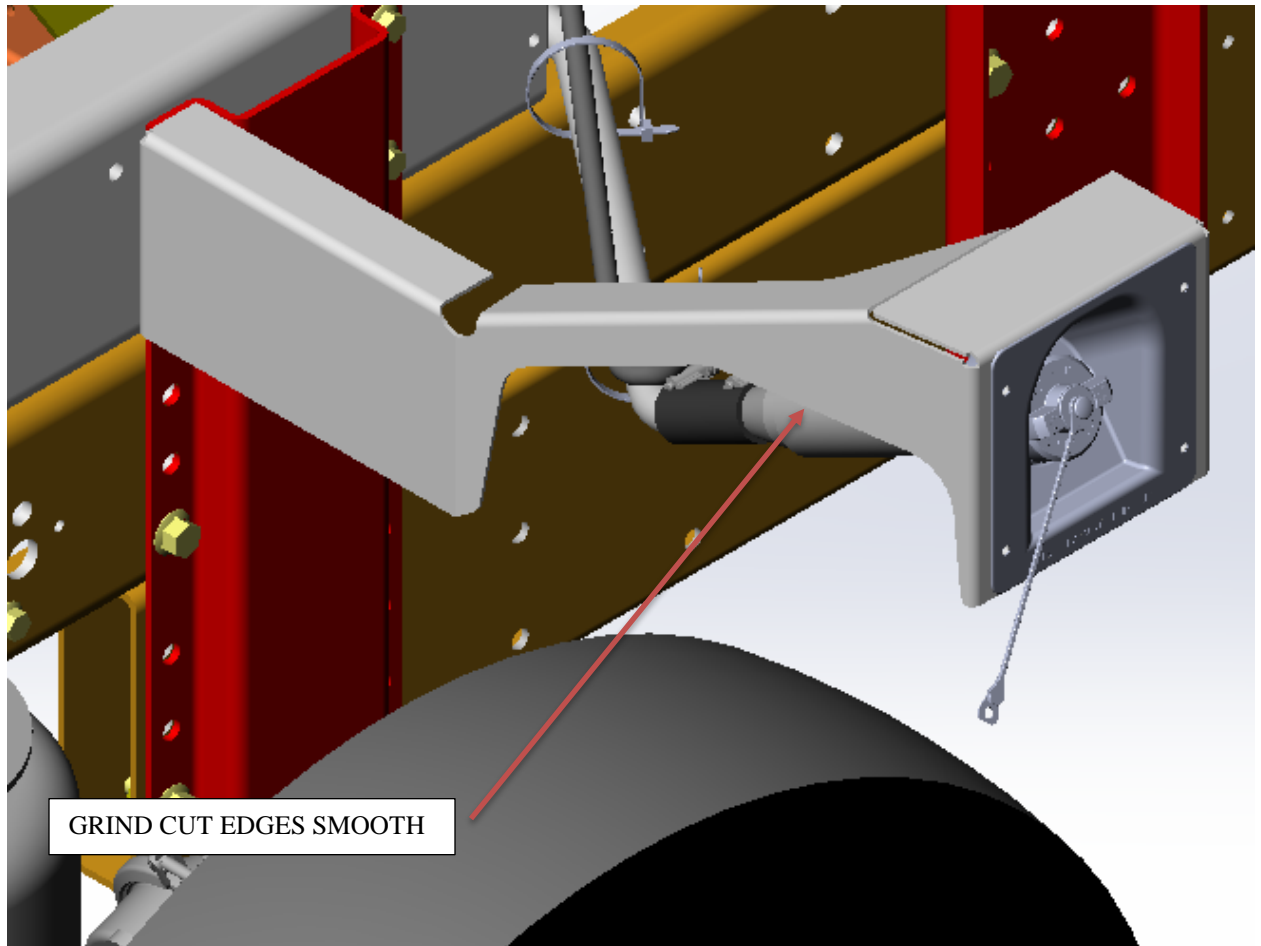
FIG. 4-1

8. Grind cut edges of bracket remaining on coach, smooth. Refer to FIG. 4-1.
9. Paint bracket remaining on coach, using black paint. (Paint not included in service kit)

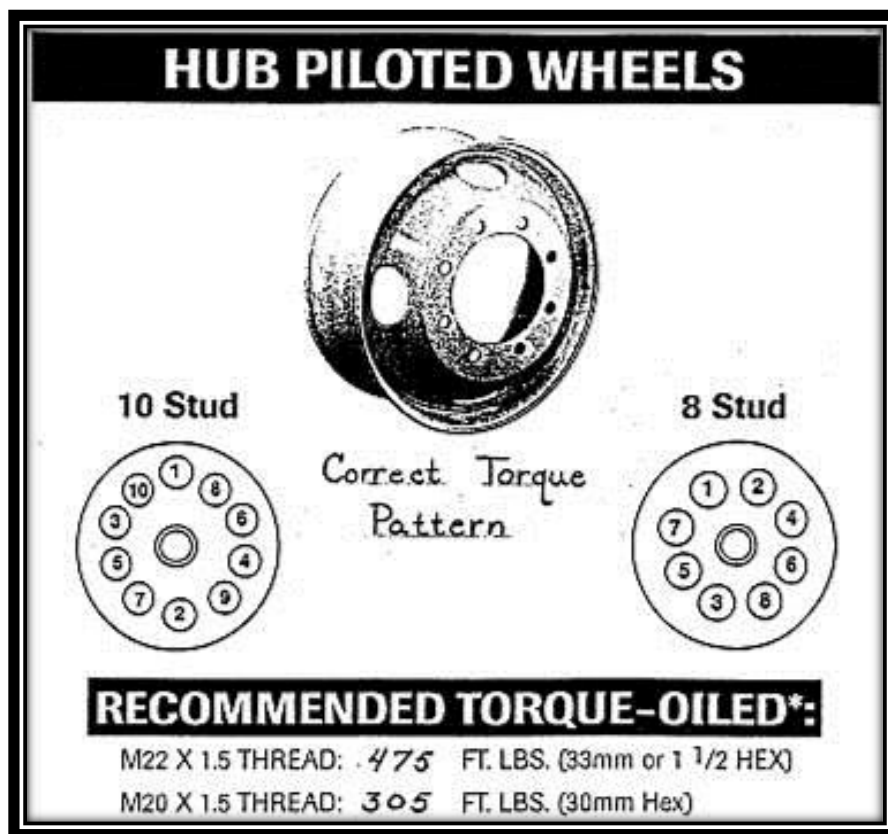
**FIG. 5-1**

10. Reinstall tag axle tire. Torque lug nuts to 475 lbf-ft using a star pattern. Refer to FIG. 5-1.
