**RSB 562**  
**April 16, 2021**

**NHTSA #21V 088**  
**TC #2021-073**

## RECALL SERVICE BULLETIN

### Recall Service Bulletin RSB21-260-001

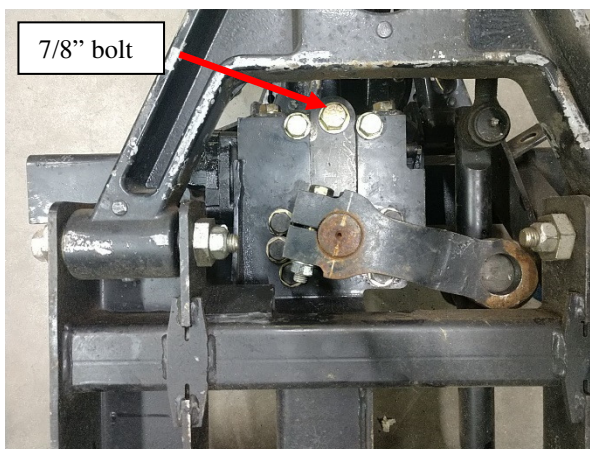
**Figure 1**

1. Raise the vehicle high enough to get the tires off the ground and safely support per industry standards.
2. Begin with the driver side steering gear and reference Figure 1. Remove the 7/8" bolt and flat washer attached to bottom of steering gear. Discard bolt and washer.
3. Clean the threaded hole in the steering gear.
4. Install new 7/8-14 x 2.00" bolt with 7/8" Nord-Lock® washer. Torque to 500 LB-FT +/- 25 LB-FT. Mark fastener to indicate it has been torqued.

5. Remove one of the two 3/4" bolts closest to the 7/8" bolt attached to bottom of steering gear mounting plate. Discard bolt and flat washer.
6. Clean the threaded hole.
7. Install new 3/4-16 x 1.50" bolt with 3/4" Nord-Lock® washer. Torque to 300 LB-FT +/- 10 LB-FT. Mark fastener to indicate it has been torqued.
8. Repeat steps 5 thru 7 for other 3/4" bolt nearest the 7/8" bolt.

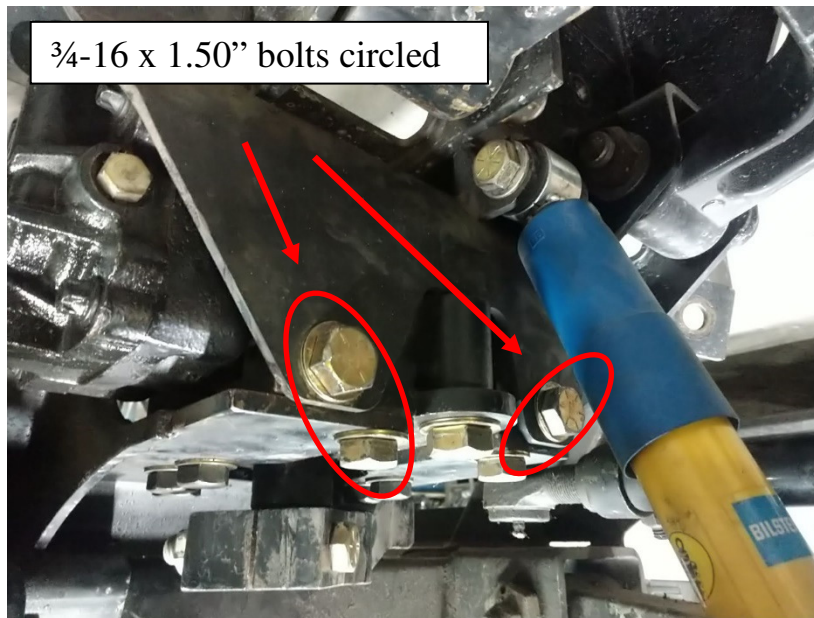
**Figure 2**

9. Referencing Figure 2, remove one of the two  $\frac{3}{4}$ " bolts attached to side of steering gear mounting plate. Discard bolt and flat washer.
10. Clean the threaded hole.
11. Install new  $\frac{3}{4}$ -16 x 1.50" bolt with  $\frac{3}{4}$ " Nord-Lock® washer. Torque to 300 LB-FT +/- 10 LB-FT. Mark fastener to indicate it has been torqued.
12. Repeat steps 9 thru 11 for other  $\frac{3}{4}$ " bolt attached to side of steering gear mounting plate.

Note: Shallow socket and open end wrench required to remove bolt behind shock absorber.

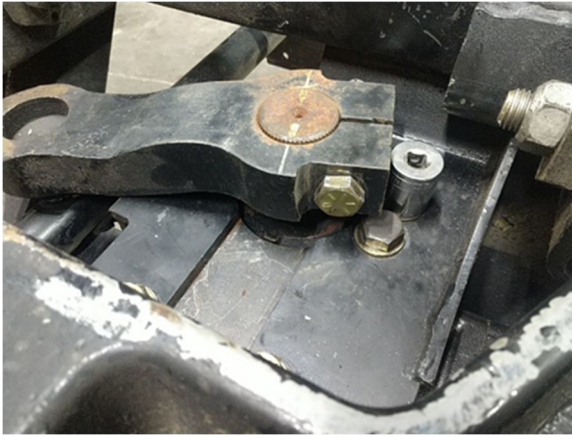
**Figure 3**

13. Turn steering wheel or steering gear input shaft incrementally to rotate the pitman arm for access to the six bolts surrounding the steering gear output shaft. Reference Figure 3.

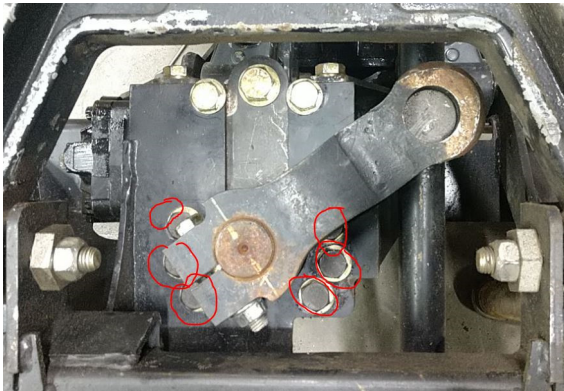
**Figure 4**

14. Referencing Figure 4, remove one of the six  $\frac{3}{4}$ " bolts surrounding the output shaft. Discard bolt and flat washer.

15. Clean the threaded hole in the steering gear.
16. Install new  $\frac{3}{4}$ -16 x 2.00" bolt with  $\frac{3}{4}$ " Nord-Lock® washer. Torque to 300 LB-FT +/- 10 LB-FT. Mark fastener to indicate it has been torqued.
17. Repeat steps 13 thru 16 for each of the remaining five  $\frac{3}{4}$ " bolts surrounding the output shaft.

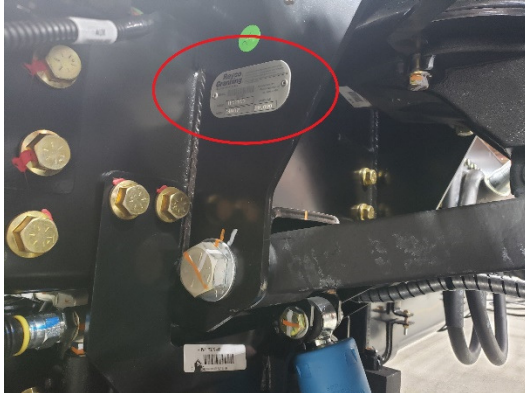
18. If suspension model is an IFS2000S3, repeat steps 3 thru 17 on the passenger side for the slave gear.
19. Document IFS serial number.
  - a. Serial number is listed on data tag located on front face of driver side air spring tower. Reference Figure 5 & Figure 6 for serial number location.
