# Newmar Corporation

**TSB 564**  
**April. 05, 2021**

## TECHNICAL SERVICE BULLETIN

# [Tech Only] Work Instructions for Testing Rooftop Air Conditioners on Super C Coaches

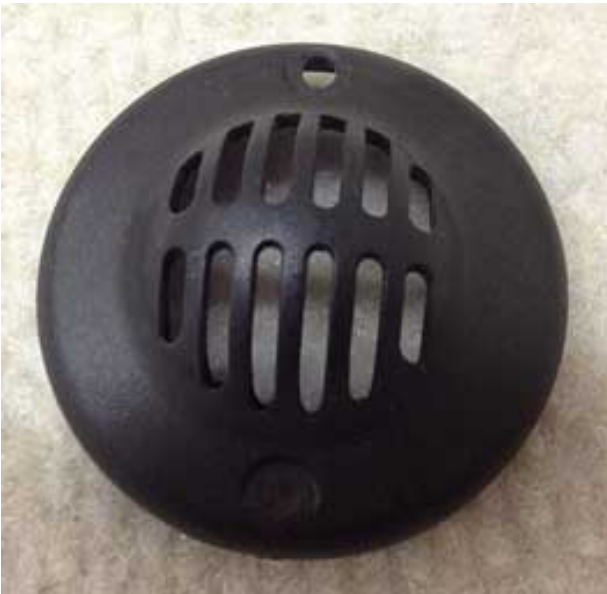
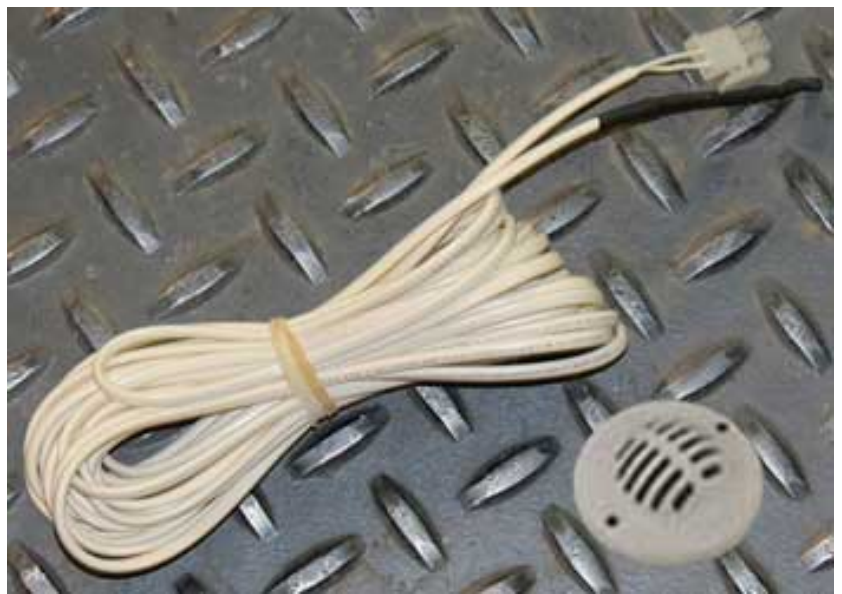
- If the sensor is plugged in, look for the opposite end in the baggage area near the bedroom slideout, in a junction box under the rear slideout, or in the front area near the cable carrier channels for the slideout wiring. Fish the wire from the current location or run a new remote sensor to a suitable interior location (depending on the best solution for the coach).

- If the sensor is not plugged in, run a new 20 or 40 foot remote sensor from the air conditioner to the easiest interior wall. Depending on the layout of the coach, it may be easier to run wire through the ceiling and into a cabinet or wall instead of fishing through the cable carrier and through the slideout wall(s).
