Technical Service Bulletin

re: Maintenance Check Point

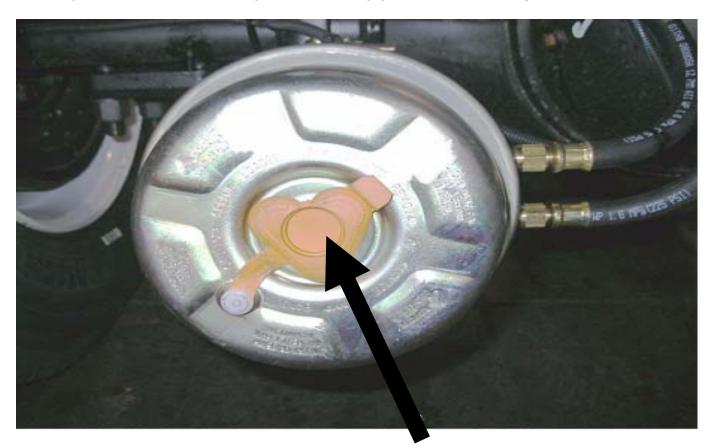
One step we wish you would take to preserve the performance and function of your vehicle brake system is to inspect the Haldex brake chambers for the presence and proper installation of the dust plugs. Dislodged or missing dust plugs can lead to corrosion in these chambers when exposed to road surface traction treatments such as road salt.

Properly installed Dust Plug in Haldex Brake Chamber

Should you need to purchase replacement dust plugs you should contact your preferred service center (request part # RPT 1) or contact Spartan Chassis at 800-722-3025 for the service center nearest you.
