NEWMAR CORPORATION WARRANTY DEPARTMENT

TECHNICAL SERVICE BULLETIN

TSB #
213

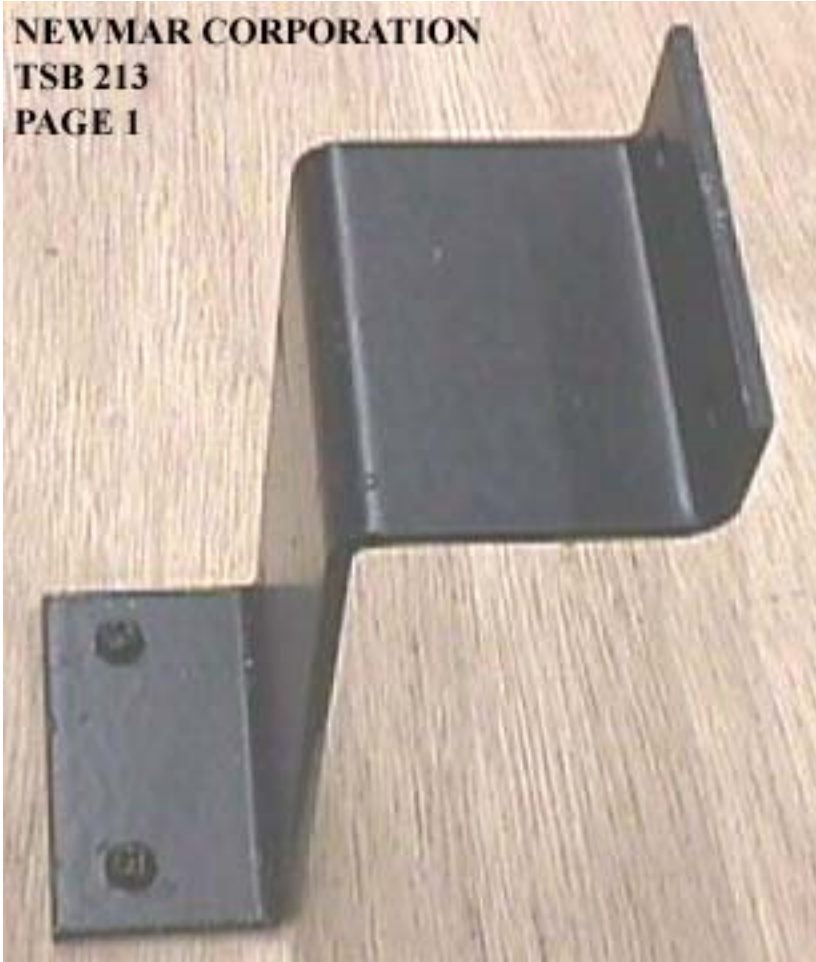
On all models, except those featuring the kitchen slide out or those models without the hardwood cabinetry option, the standard kitchen cabinet base needs to have the support as described below.

Install a toe kick bracket (See attached picture) at the bottom of each vertical style or pair of vertical styles on kitchen base cabinets. This solution applies to wrapped style cabinet construction only. This bracket will support the front and top of the cabinet due to the vertical styles stopping short of the floor. Toe kick bracket part number 34369.
