NEWMAR CORPORATION WARRANTY DEPARTMENT

TECHNICAL SERVICE BULLETIN							
DATE ISSUED	MODEL YEAR(S) AFFECTED	MODEL(S) AFFECTED	TSB #				
10/9/92	1993	ALL	65				
BRAND		TYPE					
All <input checked="" type="checkbox"/>	American Star <input type="checkbox"/>	Kountry Star <input type="checkbox"/>	Dutch Star <input type="checkbox"/>	All <input checked="" type="checkbox"/>	T T <input type="checkbox"/>	F W <input type="checkbox"/>	
NewAire <input type="checkbox"/>	Mountain Aire <input type="checkbox"/>	Kountry Aire <input type="checkbox"/>	London Aire <input type="checkbox"/>	C A <input type="checkbox"/>	D P <input type="checkbox"/>	D B <input type="checkbox"/>	
<input type="checkbox"/> Air Conditioning & Heating				<input checked="" type="checkbox"/> Electrical Components			
<input type="checkbox"/> Appliances & Accessories				<input type="checkbox"/> Exterior Components			
<input type="checkbox"/> Cabinets & Furniture				<input type="checkbox"/> Interior Components

NEWMAR CORP. SLIDE-OUT SWITCH WIRING PROCEDURE

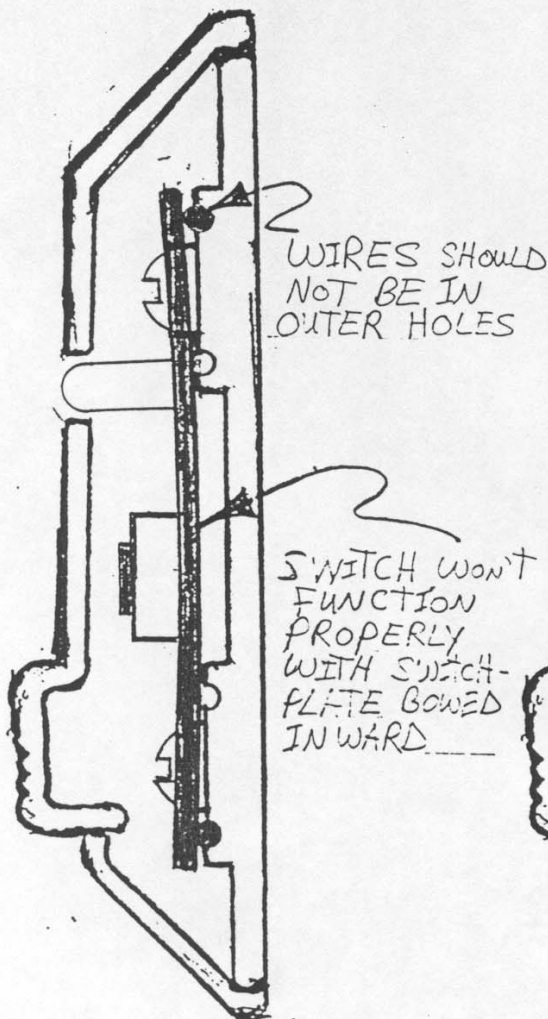
INCORRECT

<input type="checkbox"/> Chassis Components				<input type="checkbox"/> Plumbing & Bath Components			
<input type="checkbox"/> Construction Components				<input type="checkbox"/> Windows, Awnings, Vents, & Doors			
DESCRIPTION OF PROBLEM							
Slide out switch is not operating correctly due to not being wired right.							
RECOMMENDED SOLUTION							
Slide out switch wires must be changed per slide view print enclosed.

ENLARGED - CUT AWAY VIEW
OF THE SLIDE-OUT SWITCH
